Asbestos Management Survey Report

The Grange (1-6 Communal Areas), Wyld Close, Swindon, SN25 2EY

Date of Survey:	30 Mar 2017
Date of Report:	7 Apr 2017
<u>Job No:</u>	<u>J009104</u>
Authorising Surveyor:	Chris Swioklo
Verified/Signature:

Management Survey of the communal areas

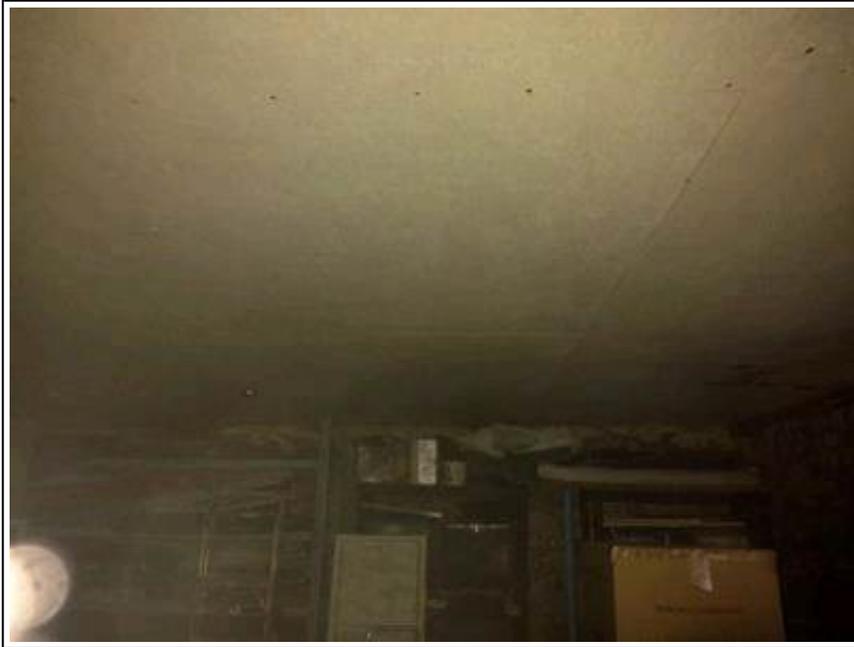
Survey Data Sheet: Conclusions & Recommendations
 Site Location: The Grange (1-6 Communal Areas), Wyld Close, Swindon, SN25 2EY
 Building Designation: Building 01
 Unique item Number: 1

Sample Ref	FI	Location	Description	Qty	Analysis Result	Total M.A.S	Licensed Material Y/N
AO001271	Z-Sub Level 1	Cellar Main Store. B01	Ceiling - Insulation board panels - Insulating Board	25m ²	NADIS		Y

Recommendations:
 No asbestos detected in sample

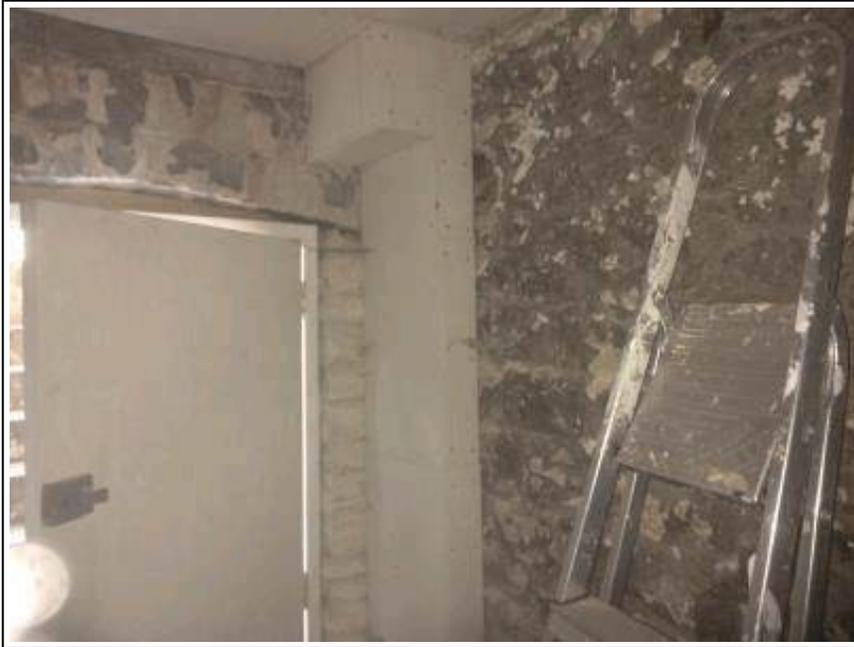
Survey Data Sheet: Conclusions & Recommendations
 Site Location: The Grange (1-6 Communal Areas), Wyld Close, Swindon, SN25 2EY
 Building Designation: Building 01
 Unique item Number: 2

Sample Ref	FI	Location	Description	Qty	Analysis Result	Total M.A.S	Licensed Material Y/N
REFER (AO001271)	Z-Sub Level 1	Cellar Main Store. B01	Adjacent to door - Insulation board boxing - Insulating Board	3lm	NADIS		Y

Recommendations:
 No asbestos detected in sample

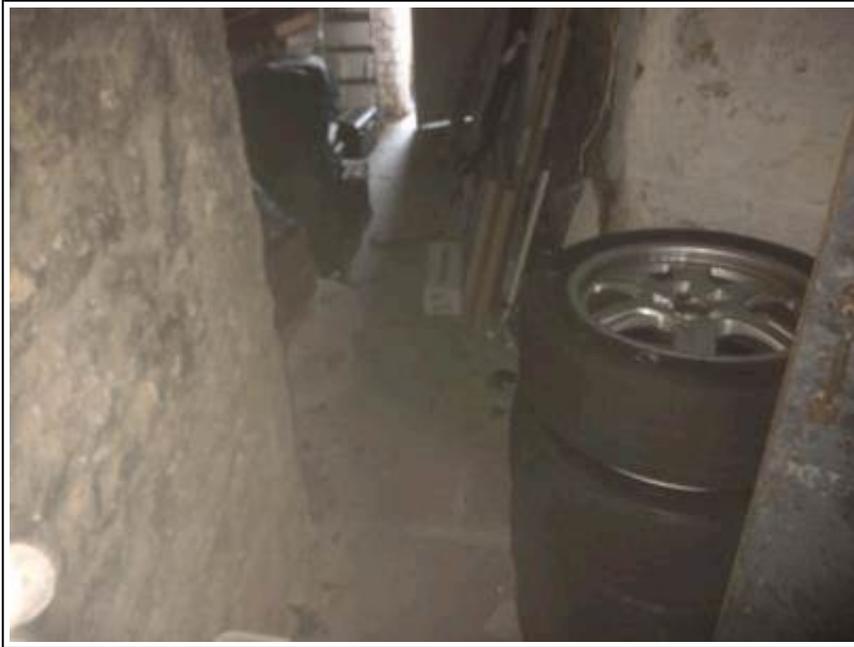
Survey Data Sheet: Conclusions & Recommendations
 Site Location: The Grange (1-6 Communal Areas), Wyld Close, Swindon, SN25 2EY
 Building Designation: Building 01
 Unique item Number: 3

Sample Ref	FI	Location	Description	Qty	Analysis Result	Total M.A.S	Licensed Material Y/N
Surveyed	Z-Sub Level 1	Cellar Circulation. B02	No asbestos detected -		N/A		N/A

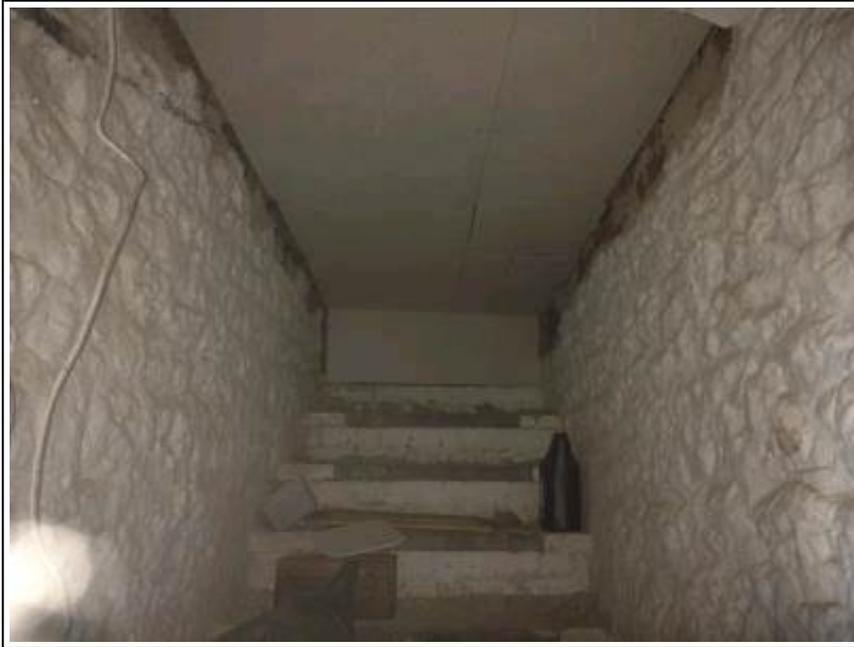
Survey Data Sheet: Conclusions & Recommendations
 Site Location: The Grange (1-6 Communal Areas), Wyld Close, Swindon, SN25 2EY
 Building Designation: Building 01
 Unique item Number: 4

Sample Ref	FI	Location	Description	Qty	Analysis Result	Total M.A.S	Licensed Material Y/N
REFER (AO001271)	Z-Sub Level 1	Original Stairwell. B03	Ceiling - Insulation board panels - Insulating Board	3m ²	NADIS		Y

Recommendations:
 No asbestos detected in sample

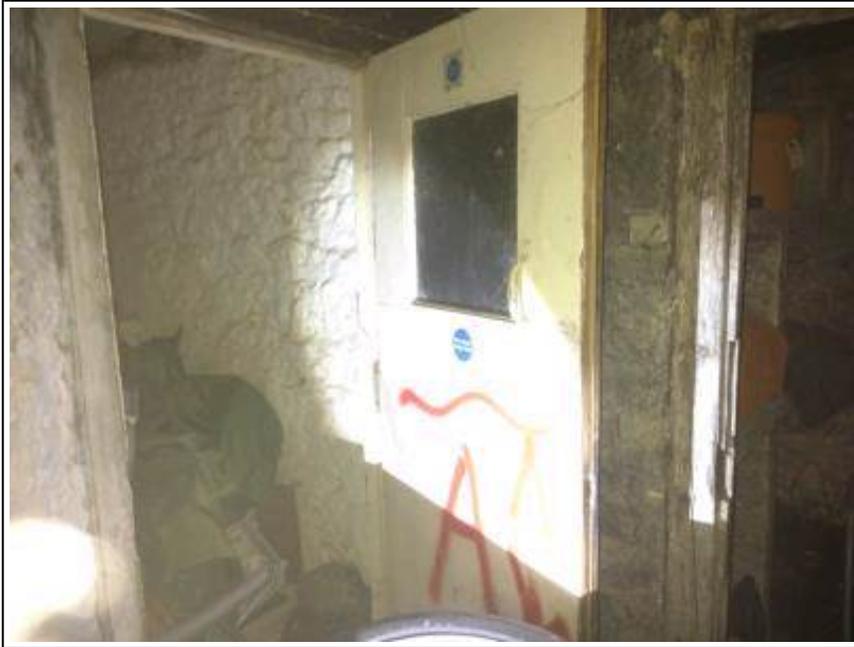
Survey Data Sheet: Conclusions & Recommendations
 Site Location: The Grange (1-6 Communal Areas), Wyld Close, Swindon, SN25 2EY
 Building Designation: Building 01
 Unique item Number: 5

Sample Ref	FI	Location	Description	Qty	Analysis Result	Total M.A.S	Licensed Material Y/N
AO001272	Z-Sub Level 1	Original Stairwell. B03	Door - Lining panel - Asbestos Cement	2m ²	Chrysotile	4	N

Product Type	Extent of Damage	Surface Treatment	Asbestos Type	Total M.A.S	Accessibility/Vulnerability	Combined Total for Advised Timescale
1	1	1	1	4	2	6

Recommended Action:
 Repair/Encapsulate

This material requires repair or encapsulation within current legislative requirements. Thereafter it may remain in situ and be managed accordingly. No drilling, cutting or any abrasive actions should take place on this material.

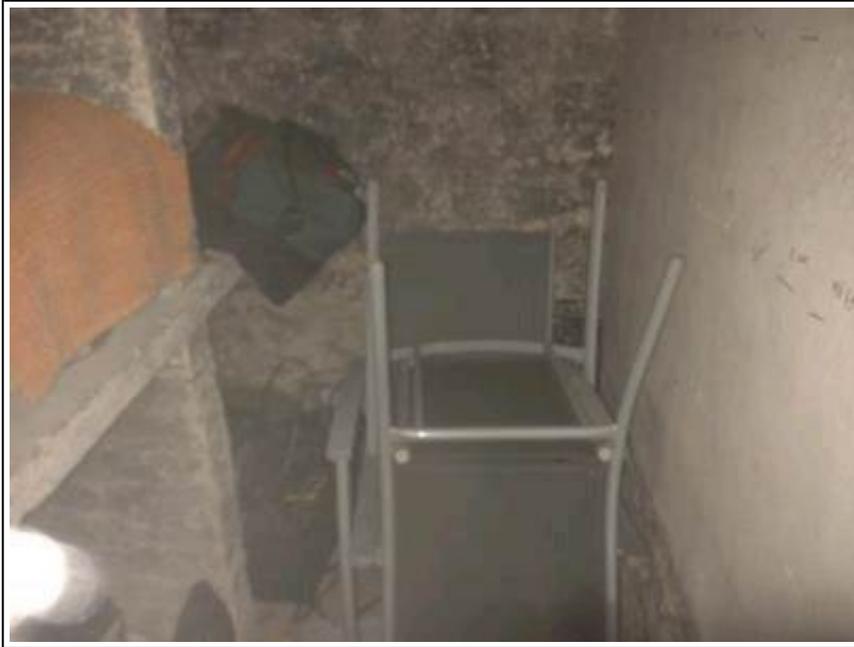
Survey Data Sheet: Conclusions & Recommendations
 Site Location: The Grange (1-6 Communal Areas), Wyld Close, Swindon, SN25 2EY
 Building Designation: Building 01
 Unique item Number: 6

Sample Ref	FI	Location	Description	Qty	Analysis Result	Total M.A.S	Licensed Material Y/N
Surveyed	Z-Sub Level 1	Secondary Cellar Store. B04	No asbestos detected -		N/A		N/A

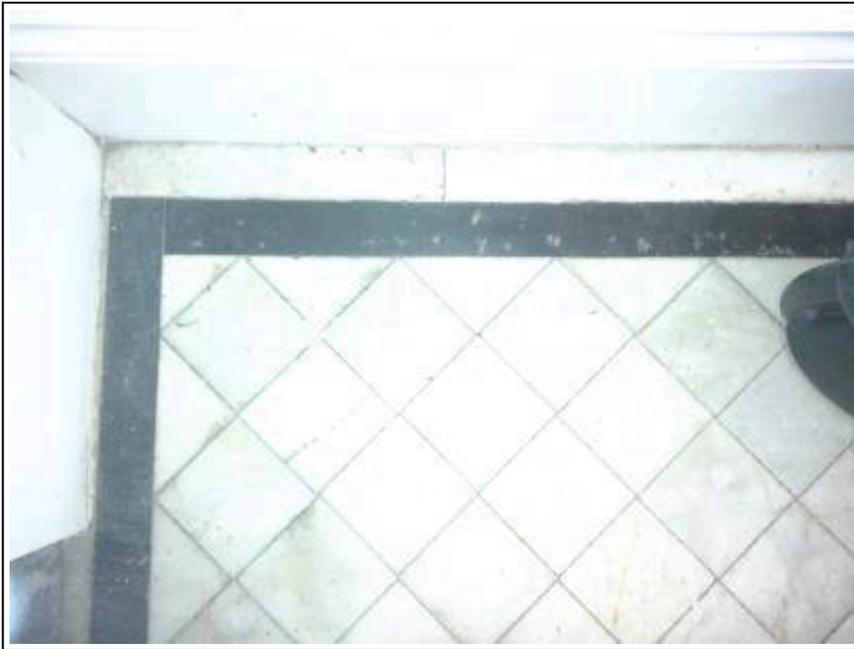
Survey Data Sheet: Conclusions & Recommendations
 Site Location: The Grange (1-6 Communal Areas), Wyld Close, Swindon, SN25 2EY
 Building Designation: Building 01
 Unique item Number: 7

Sample Ref	FI	Location	Description	Qty	Analysis Result	Total M.A.S	Licensed Material Y/N
A0001268	Ground Floor	Entrance Hall. G01	Floor - Black composite floor strip - Reinforced Composite	8lm	NADIS		N

Recommendations:
 No asbestos detected in sample

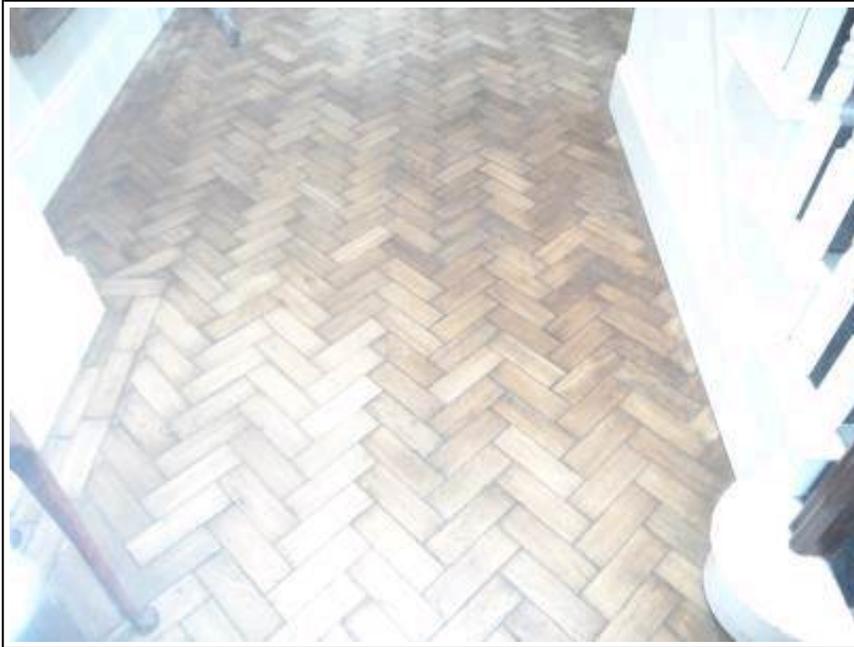
Survey Data Sheet: Conclusions & Recommendations
 Site Location: The Grange (1-6 Communal Areas), Wyld Close, Swindon, SN25 2EY
 Building Designation: Building 01
 Unique item Number: 8

Sample Ref	Fl	Location	Description	Qty	Analysis Result	Total M.A.S	Licensed Material Y/N
A0001269	Ground Floor	Stairwell. G02	Floor (below parquet) - Bitumen adhesive - Well Bound Material	15m ²	NADIS		N

Recommendations:
 No asbestos detected in sample

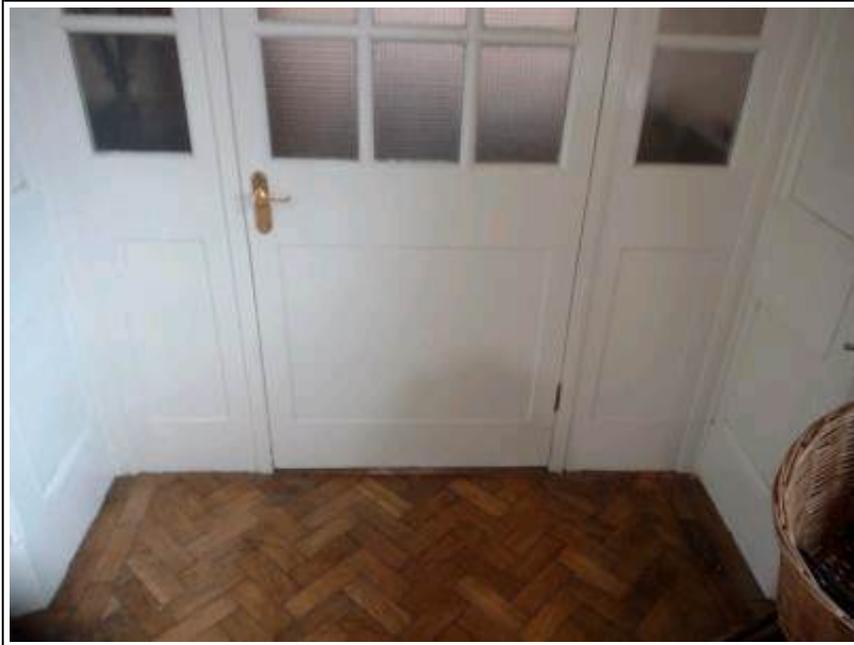
Survey Data Sheet: Conclusions & Recommendations
 Site Location: The Grange (1-6 Communal Areas), Wyld Close, Swindon, SN25 2EY
 Building Designation: Building 01
 Unique item Number: 9

Sample Ref	FI	Location	Description	Qty	Analysis Result	Total M.A.S	Licensed Material Y/N
AO001270	Ground Floor	Stairwell. G02	Below and to sides of door to Circulation. G05 - Insulation board panels - Insulating Board	2m ²	NADIS		Y

Recommendations:
 No asbestos detected in sample

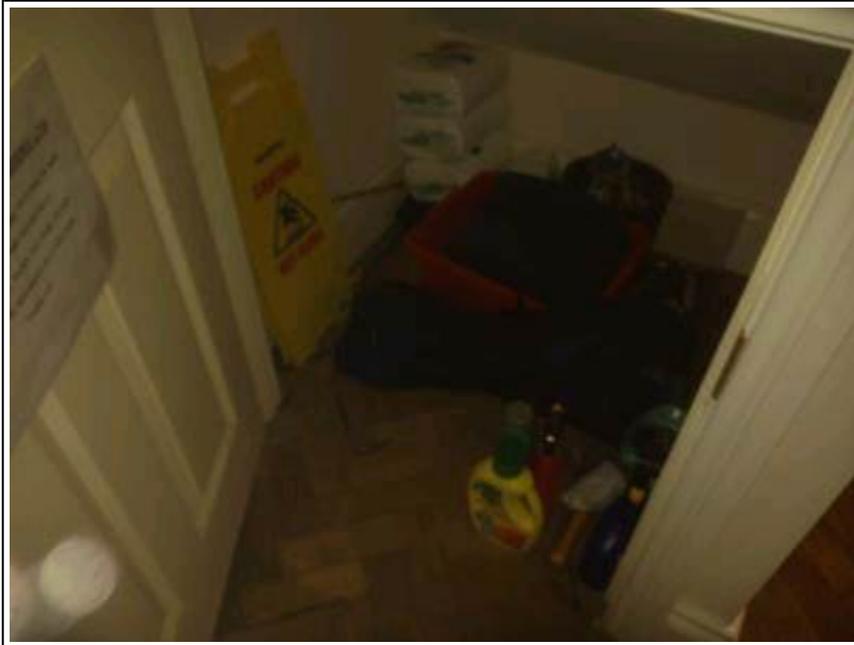
Survey Data Sheet: Conclusions & Recommendations
 Site Location: The Grange (1-6 Communal Areas), Wyld Close, Swindon, SN25 2EY
 Building Designation: Building 01
 Unique item Number: 10

Sample Ref	FI	Location	Description	Qty	Analysis Result	Total M.A.S	Licensed Material Y/N
REFER (AO001269)	Ground Floor	Understairs Cupboard. G03	Floor (below parquet) - Bitumen adhesive - Well Bound Material	2m ²	NADIS		N

Recommendations:
 No asbestos detected in sample

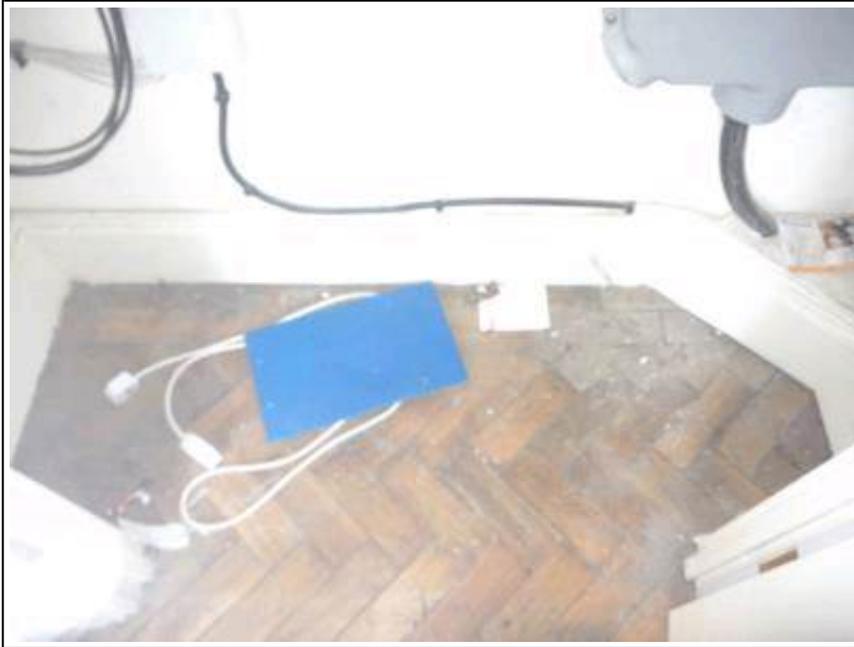
Survey Data Sheet: Conclusions & Recommendations
 Site Location: The Grange (1-6 Communal Areas), Wyld Close, Swindon, SN25 2EY
 Building Designation: Building 01
 Unique item Number: 11

Sample Ref	FI	Location	Description	Qty	Analysis Result	Total M.A.S	Licensed Material Y/N
REFER (AO001269)	Ground Floor	Electric Cupboard. G04	Floor (below parquet) - Bitumen adhesive - Well Bound Material	1m ²	NADIS		N

Recommendations:
 No asbestos detected in sample

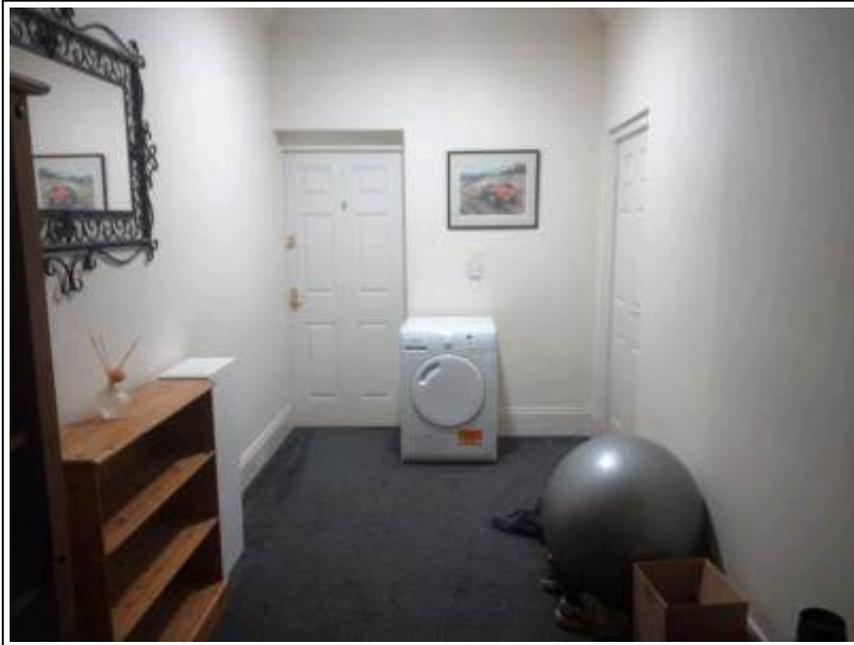
Survey Data Sheet: Conclusions & Recommendations
 Site Location: The Grange (1-6 Communal Areas), Wyld Close, Swindon, SN25 2EY
 Building Designation: Building 01
 Unique item Number: 12

Sample Ref	FI	Location	Description	Qty	Analysis Result	Total M.A.S	Licensed Material Y/N
Surveyed	Ground Floor	Circulation (Flats 2 and 3). G05	No asbestos detected -		N/A		N/A

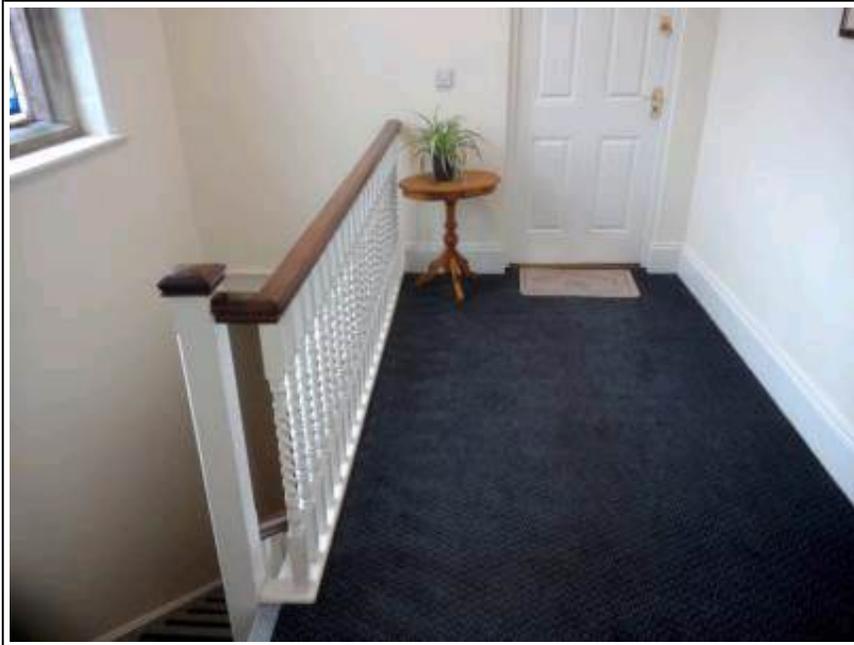
Survey Data Sheet: Conclusions & Recommendations
 Site Location: The Grange (1-6 Communal Areas), Wyld Close, Swindon, SN25 2EY
 Building Designation: Building 01
 Unique item Number: 13

Sample Ref	Fl	Location	Description	Qty	Analysis Result	Total M.A.S	Licensed Material Y/N
Surveyed	1st Floor	Stairs/Landing. 101	No asbestos detected -		N/A		N/A

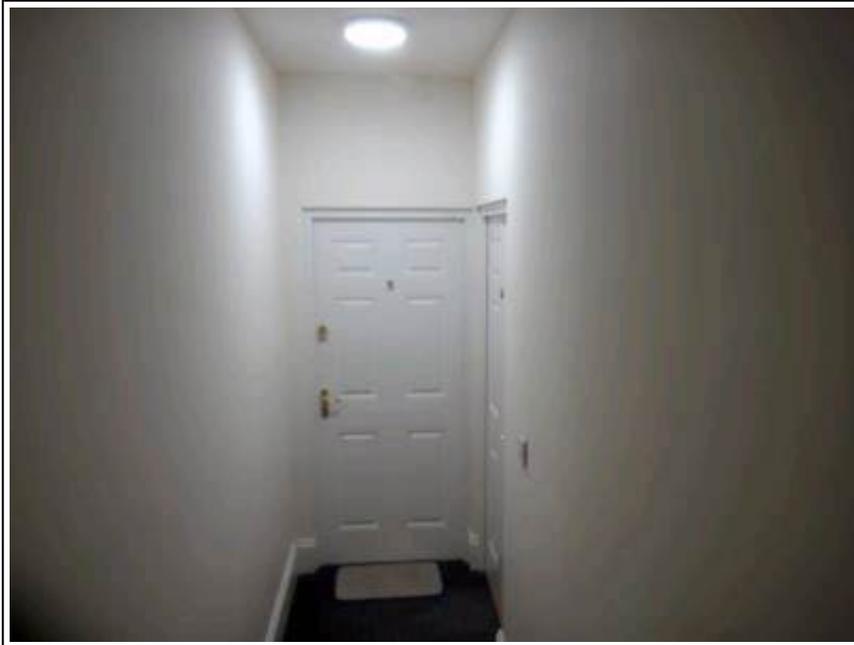
Survey Data Sheet: Conclusions & Recommendations
 Site Location: The Grange (1-6 Communal Areas), Wyld Close, Swindon, SN25 2EY
 Building Designation: Building 01
 Unique item Number: 14

Sample Ref	F1	Location	Description	Qty	Analysis Result	Total M.A.S	Licensed Material Y/N
Surveyed	1st Floor	Corridor (flats 5 and 6). 102	No asbestos detected -		N/A		N/A

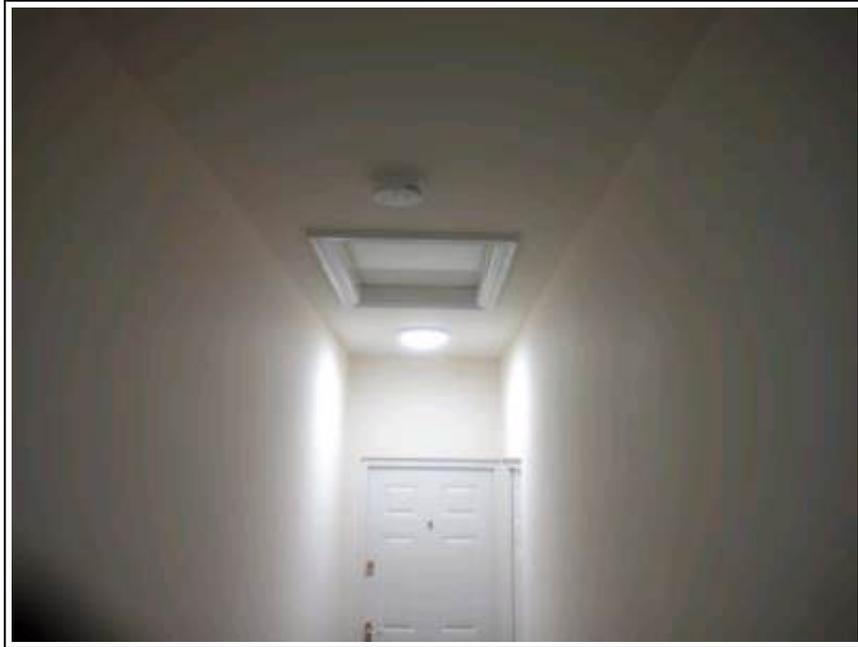
Survey Data Sheet: Conclusions & Recommendations
 Site Location: The Grange (1-6 Communal Areas), Wyld Close, Swindon, SN25 2EY
 Building Designation: Building 01
 Unique item Number: 15

Sample Ref	FI	Location	Description	Qty	Analysis Result	Total M.A.S	Licensed Material Y/N
Surveyed	Roof Void	Attic	No asbestos detected -		N/A		N/A

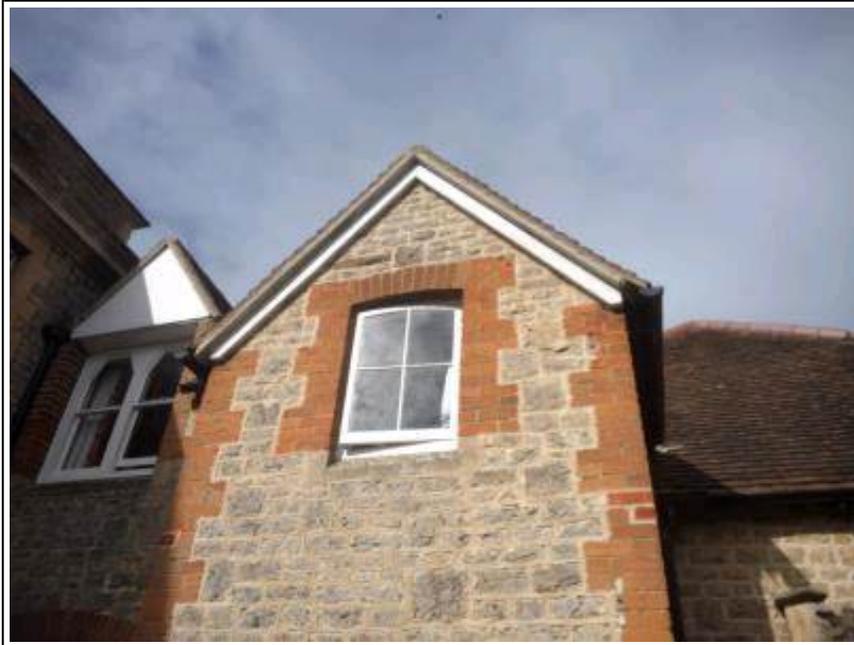
Survey Data Sheet: Conclusions & Recommendations
 Site Location: The Grange (1-6 Communal Areas), Wyld Close, Swindon, SN25 2EY
 Building Designation: Building 01
 Unique item Number: 16

Sample Ref	FI	Location	Description	Qty	Analysis Result	Total M.A.S	Licensed Material Y/N
A0001273	External	External	Roof - Undercloak - Cement	20lm	NADIS		N

Recommendations:
 No asbestos detected in sample

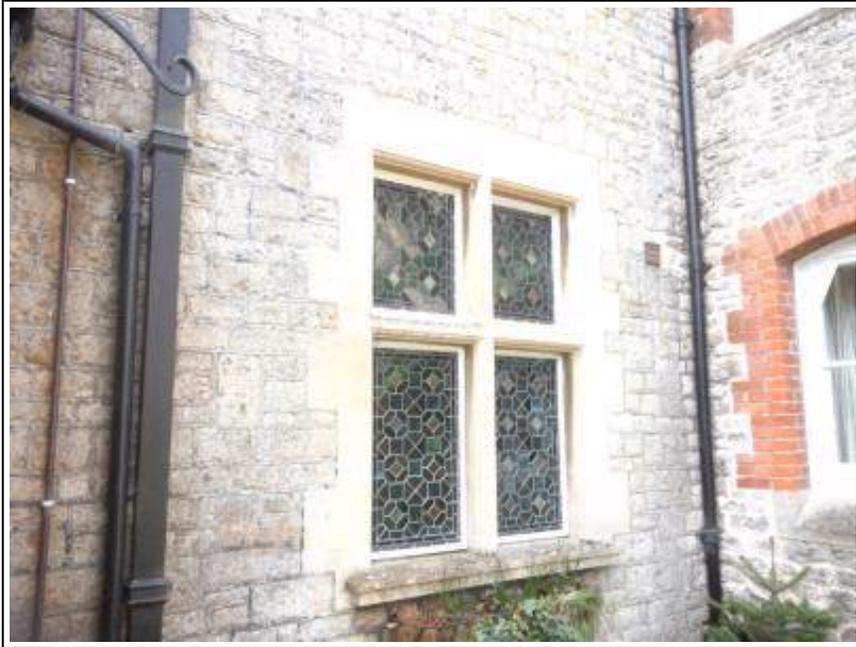
Survey Data Sheet: Conclusions & Recommendations
 Site Location: The Grange (1-6 Communal Areas), Wyld Close, Swindon, SN25 2EY
 Building Designation: Building 01
 Unique item Number: 17

Sample Ref	FI	Location	Description	Qty	Analysis Result	Total M.A.S	Licensed Material Y/N
A0001274	External	External	Stained glass windows x2 - Putty - Well Bound Material	<1m ²	NADIS		N

Recommendations:
 No asbestos detected in sample
