# COMBINED FIRE AND HEALTH & SAFETY RISK ASSESSMENT.

| Address of premises: | The Grange<br>Wyld Court<br>Swindon<br>SN25 2EY |
| Date of fire risk assessment: | 31 <sup>st</sup> October 2025 |

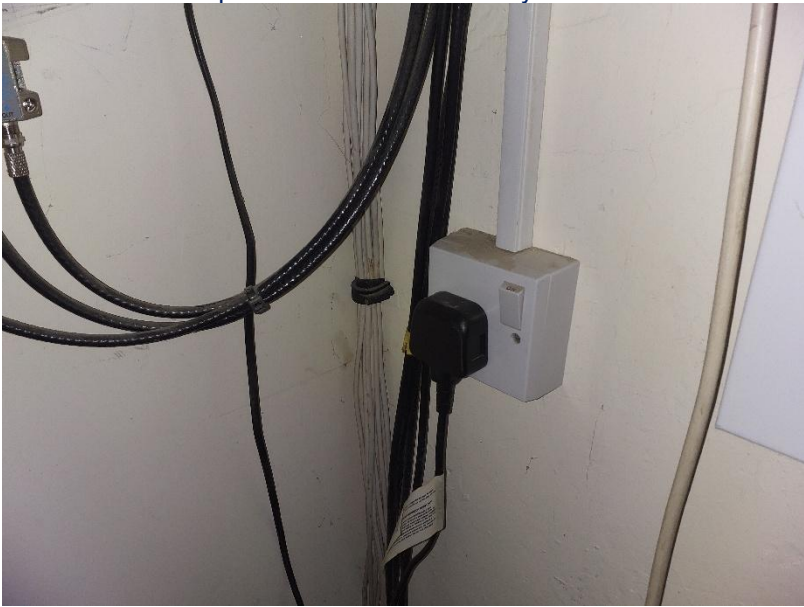
| Item | Recommendation | Priority | Timescale |
|---|---|---|---|
| 01 | <p>No portable electrical appliances were found to have been tested in the electrical intake cupboard.</p> <p>All portable electrical appliances should be inspected and tested regularly by a competent person in accordance with the requirements of Section 4(4) of the Electricity at Work Regulations 1989.</p> <p>For this premises, it is recommended that all portable electrical appliances are inspected and tested annually, therefore it is recommended that the client instruct a suitably qualified and competent contractor to ensure all portable electrical appliances are tested as soon as possible and then annually thereafter.</p> | 2 | B |

Ongoing action required

Cupboard is for contractor use.

Items are visually inspected.

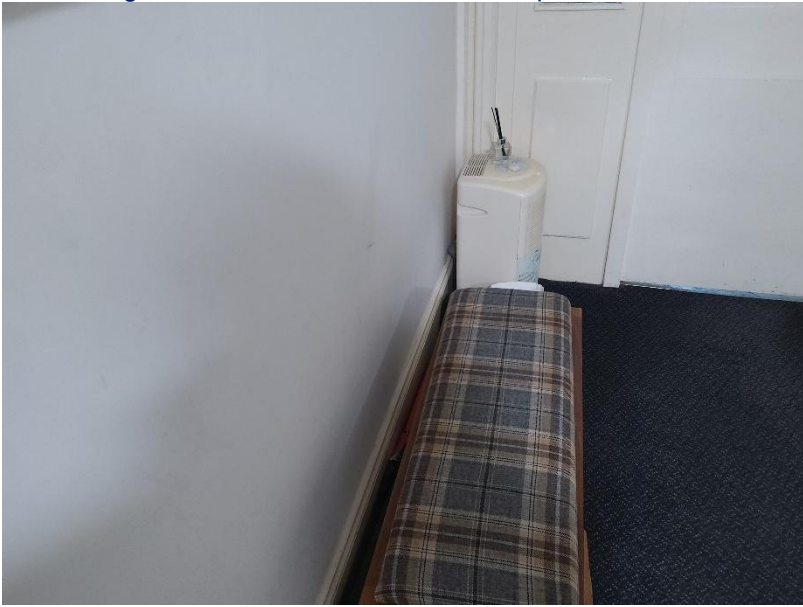
| <p>Housekeeping was found to be of a poor standard at the time of this assessment with the communal areas and escape routes congested with residents' possessions and storage. It is recommended that the client arrange for the communal areas to be cleared as a priority and all residents reminded of the importance of maintaining sterile communal areas and escape routes.</p> <p>Waste is well managed with the bin store located adjacent to the premises in domestic style wheelie bins.</p> | | |

| 02 | <p>Housekeeping was found to be of a poor standard at the time of this assessment with the communal areas and escape routes congested with residents' possessions and storage. It is recommended that the client arrange for the communal areas to be cleared as a priority and all residents reminded of the importance of maintaining sterile communal areas and escape routes.</p> | 2 | B | <p>Ongoing action required</p> <p>DH inspect communal areas and ticket items for removal.</p> <p>Residents are reminded to keep a sterile communal area.</p> |

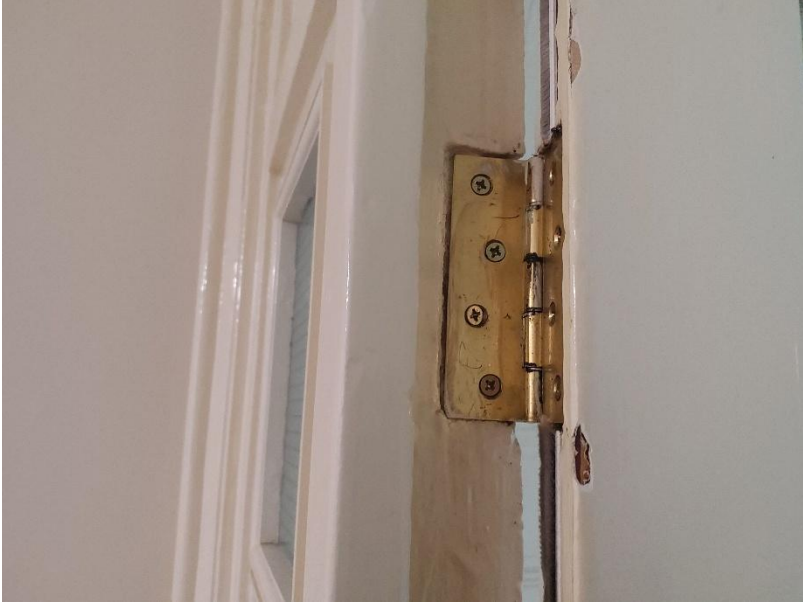
| <p>03</p> | <p>It was noted during this fire risk assessment that the identified communal area doors had the following deficiencies:</p> <ul style="list-style-type: none"> <li>No fire rated hinges on the ground floor lobby door.</li> </ul> <p>It is essential that each door communicating with the means of escape is a suitable fire door, providing a minimum of thirty minutes fire resistance, hung on three grade 13 hinges, combine cold smoke and intumescent seal, "Fire Door Keep Locked" or "Fire Door Keep Shut" signage where appropriate along with having a functioning self-closing device fitted that positively closes the door flush to the frame if a lobby door. It is recommended therefore that the RP instruct a suitably qualified and competent contractor to conduct a fire door inspection to all communal area doors providing advice on suitability. Any shortcomings identified by this inspection should be addressed as a priority by upgrading or replacing the door. Flat entrance doors, communal area doors, the seals and the self-closing devices should then be subjected to an annual inspection and maintenance schedule.</p> | <p>2</p> | <p>B</p> <p>Ongoing action required.</p> <p>Consideration to be made regarding upgrades.</p> <p>Inspection carried out per current legislation.</p> |

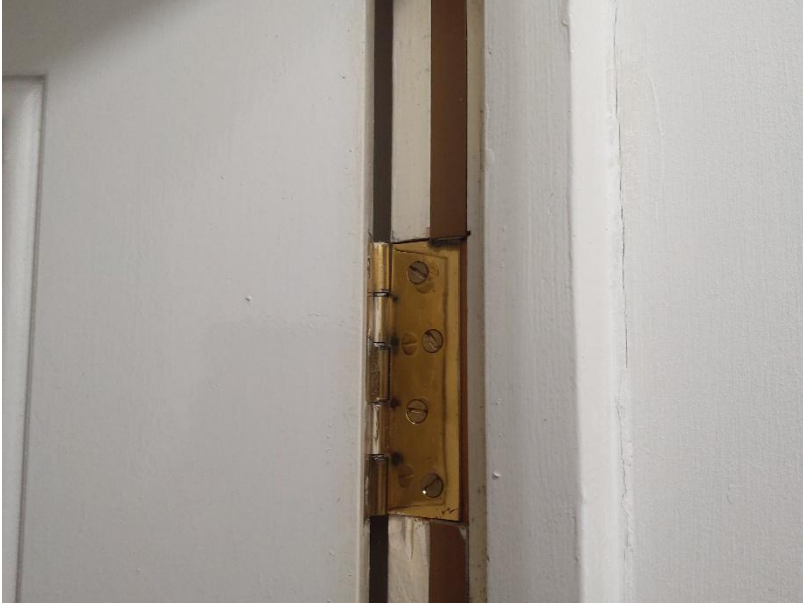
| 04 | <p>A type 1 fire risk assessment requires us to conduct a fire door survey on a sample of flat front doors. The door to flat 5 was surveyed during this sample in which the following deficiencies were found:</p> <ul style="list-style-type: none"> <li>• No fire rated hinges</li> <li>• Intumescent seal only</li> </ul> <p>It is essential that each flat entrance door is a suitable fire door, providing a minimum of thirty minutes fire resistance, hung on three grade 13 hinges and having a functioning self-closing device fitted that positively closes the door on the latch, together with smoke and intumescent seals. It is recommended therefore that the RP instruct a suitably qualified and competent contractor to conduct a fire door inspection to all flat entrance doors providing advice on suitability. Any shortcomings identified by this inspection should be addressed as a priority by upgrading or replacing the door. Flat entrance doors, communal area doors, the seals and the self-closing devices should then be subjected to an annual inspection and maintenance schedule.</p> | 1 | B | <p>Ongoing action required</p> <p>DH provide this assessment and advice on fire doors via website.</p> <p>Owner is responsible for considering upgrades.</p> |

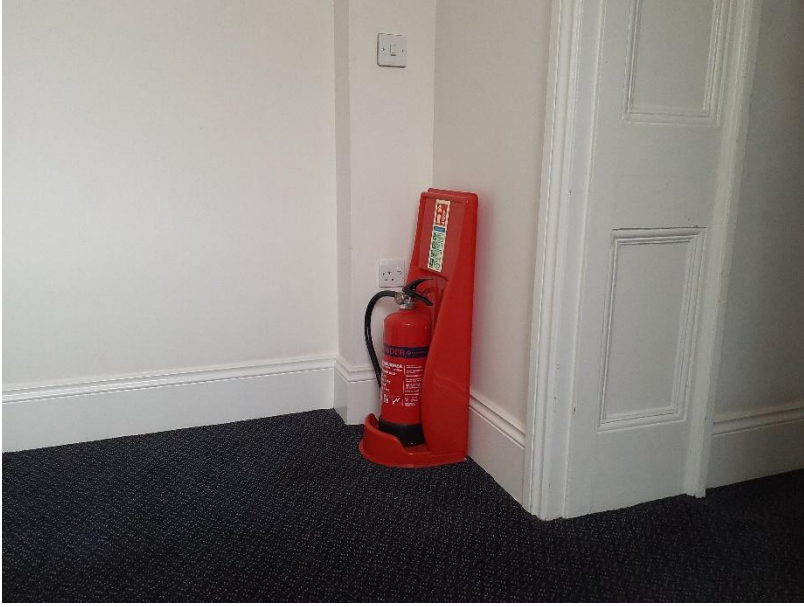
| <p>It was noted during this assessment that there are fire extinguishers installed within the common areas of the premises. It is recommended all fire extinguishers be removed from the common areas as their presence may encourage an untrained resident to attempt to fight a fire within their flat thereby placing themselves at an unnecessary level of risk and remaining within the building beyond the Available Safe Egress Time (ASET).</p> <p>It is recommended that the client encourage all residents to install a fire blanket within their kitchens.</p> | | |

| 07 | <p>It was noted during this assessment that there are fire extinguishers installed within the common areas of the premises. It is recommended all fire extinguishers be removed from the common areas as their presence may encourage an untrained resident to attempt to fight a fire within their flat thereby placing themselves at an unnecessary level of risk and remaining within the building beyond the Available Safe Egress Time (ASET).</p> | 3 | A | <p>Action required</p> <p>Contractor to consult with RP remove item.</p> |
